Culvert Replacements

Within the project area seven stream crossing have been identified as full or partial barriers to fish passage. The Forest is currently working with our national office and Salt Lake County to develop a design for each of these crossings to provide for fish passage. The replacement of these structures should also improve downstream flood and debris passage.

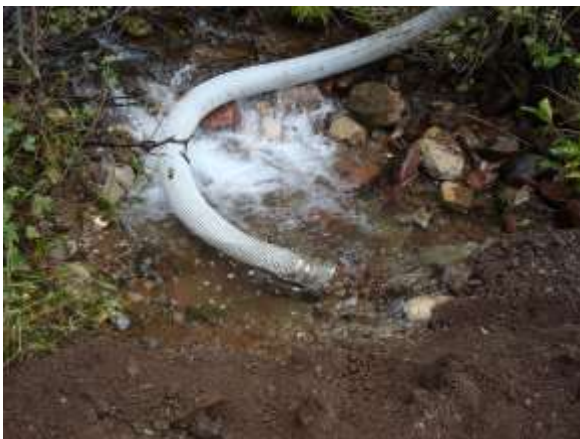
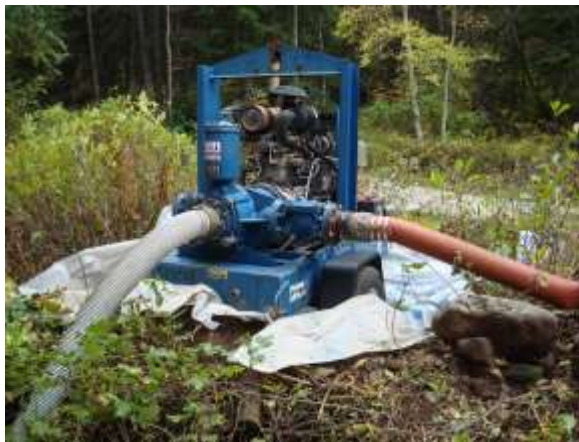
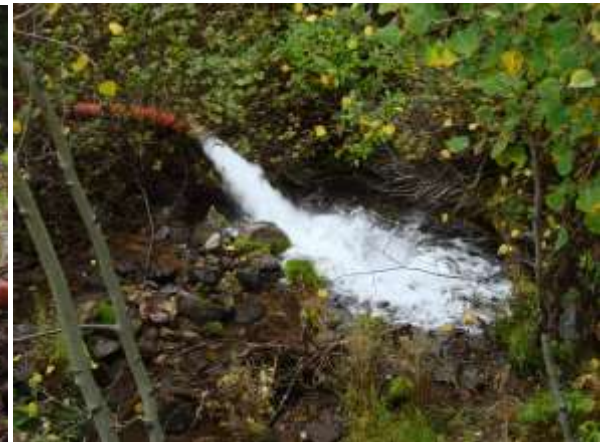
1. Develop and implement a traffic control program. In this case vehicle traffic was closed at the winter gate adjacent to Maple Grove Picnic area around the 22 of September 2014. All of the toilets above the gate were pumped dry and locked and the Big Water Yert was hauled in. A closure order around the construction sites were signed and the area was closed to public foot and bike traffic. Closure signs at the ridge lines above the project area were also installed warning people of the area closure around the construction sites.
2. Equipment was then brought in for the construction work.
3. The stream around the construction site to minimize sedimentation from moving down the stream channel which would impact aquatic insects and fish survival.

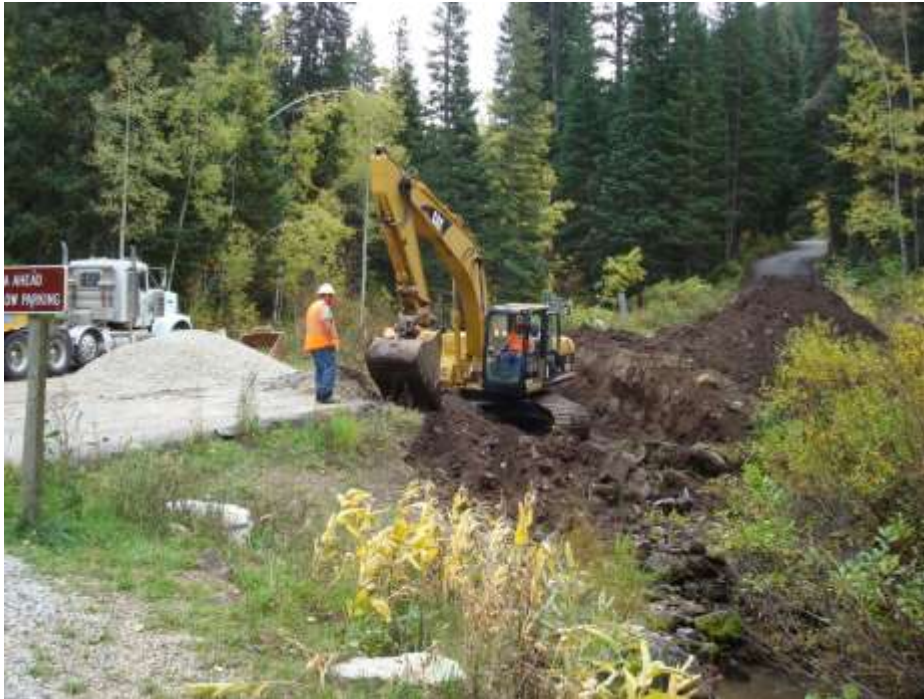
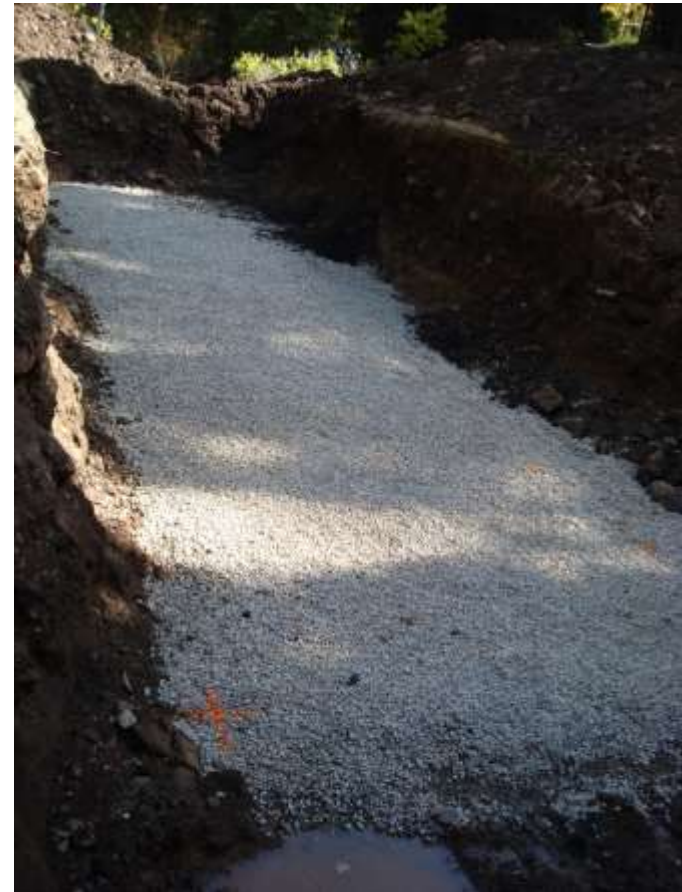
5.

4. The road blacktop is cut and the site prepared for removal of the existing structure. The existing structure is then removed and the new alignment is dug and the site is prepared for the new structure. Survey equipment is used to be sure the layout is correct.

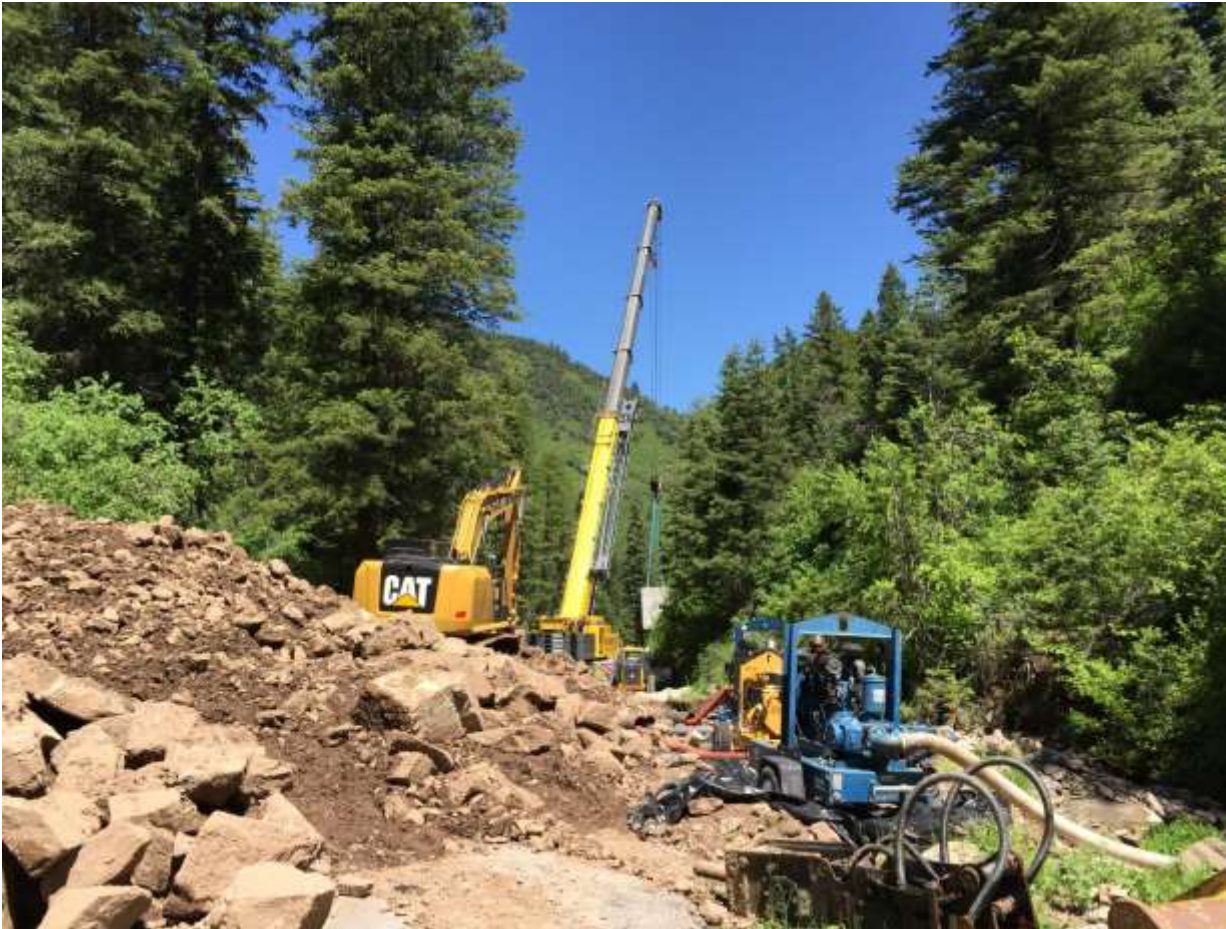
The road is used as a temporary storage location for material excavated from the new trench minimizing impacts to riparian vegetation.

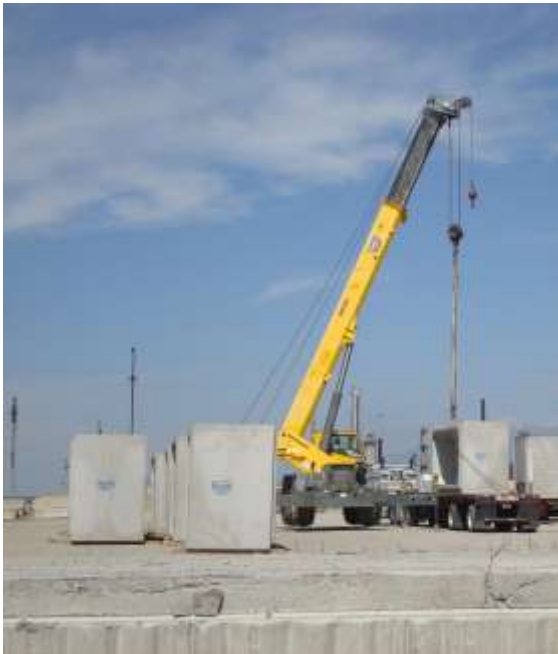
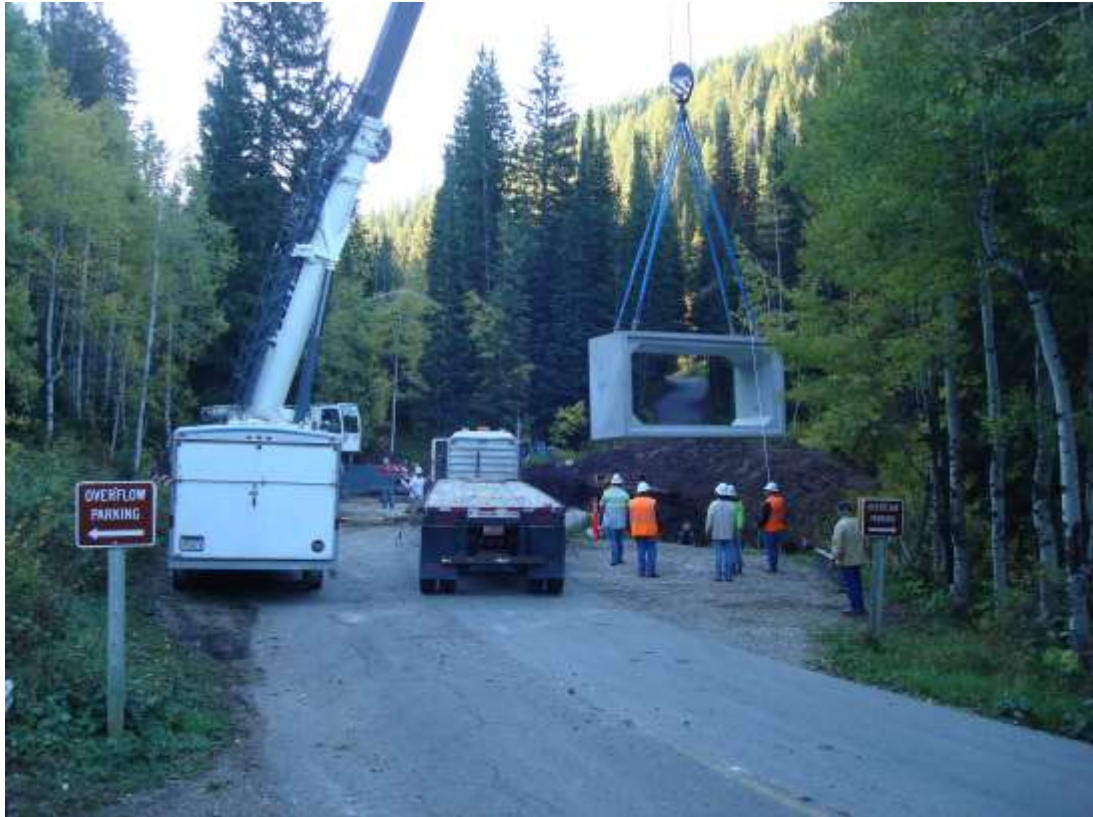
6. The new culvert sections are then brought from the manufacturing site to the installation site. Because of the weight of the individual sections only one section could be hauled up the canyon at a time. Once the section was moved into its permanent location the flat bed trail was disconnected from the truck and spun around to head back down the canyon for the next section. From the arrival of the truck on site to the truck headed back down the canyon was approximately one hour.

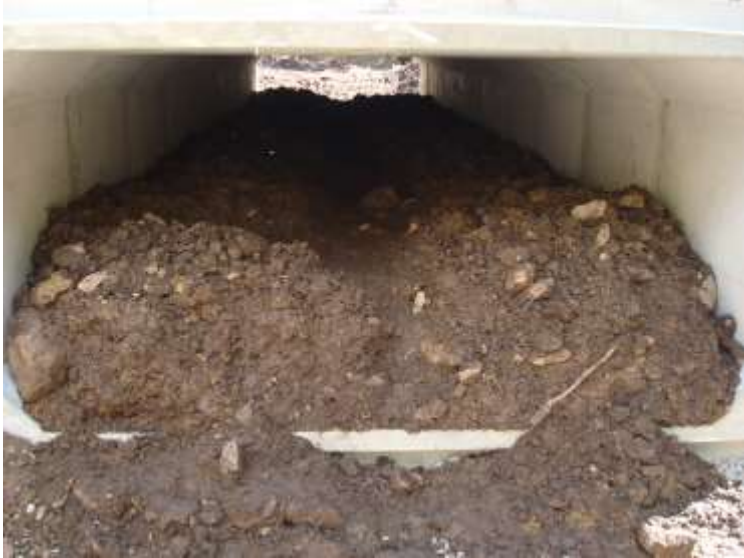
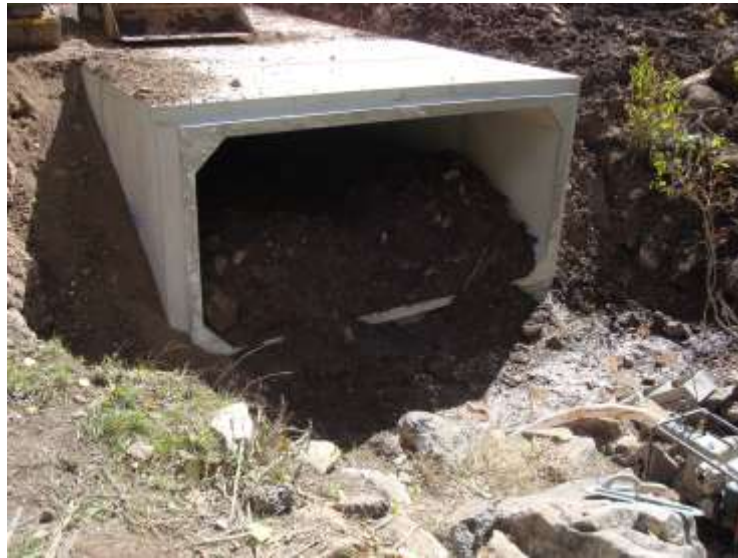
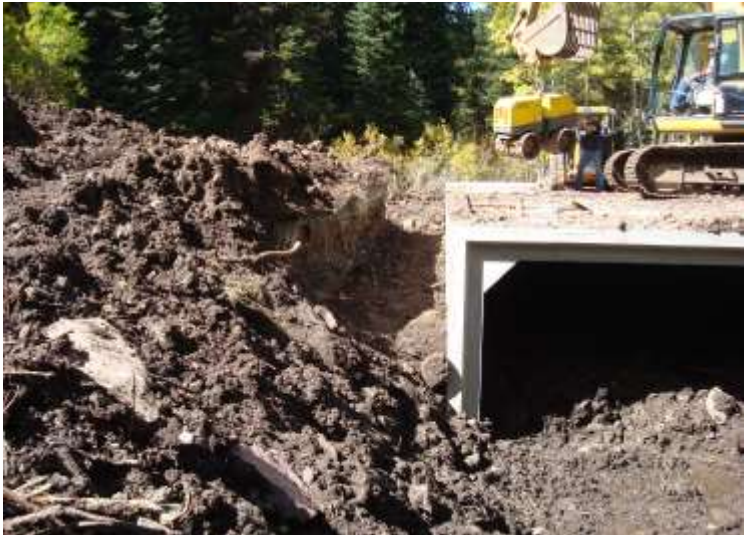
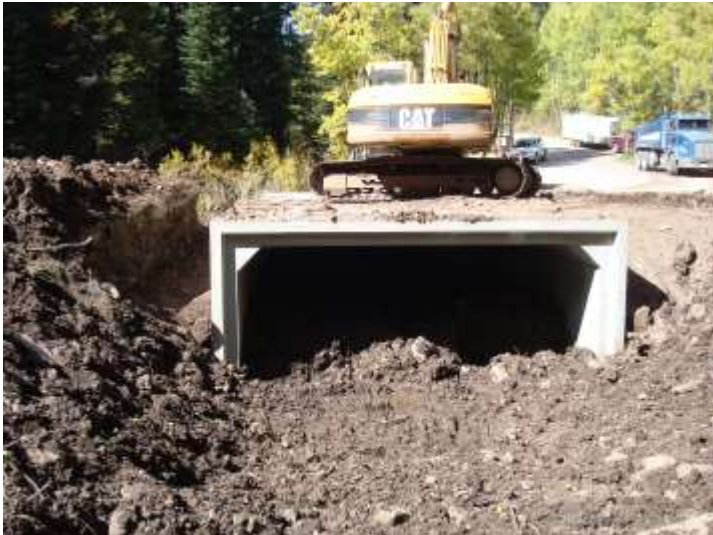
7. The culvert is then backfilled and a new natural stream bed is established in the culvert to improve fish passage.

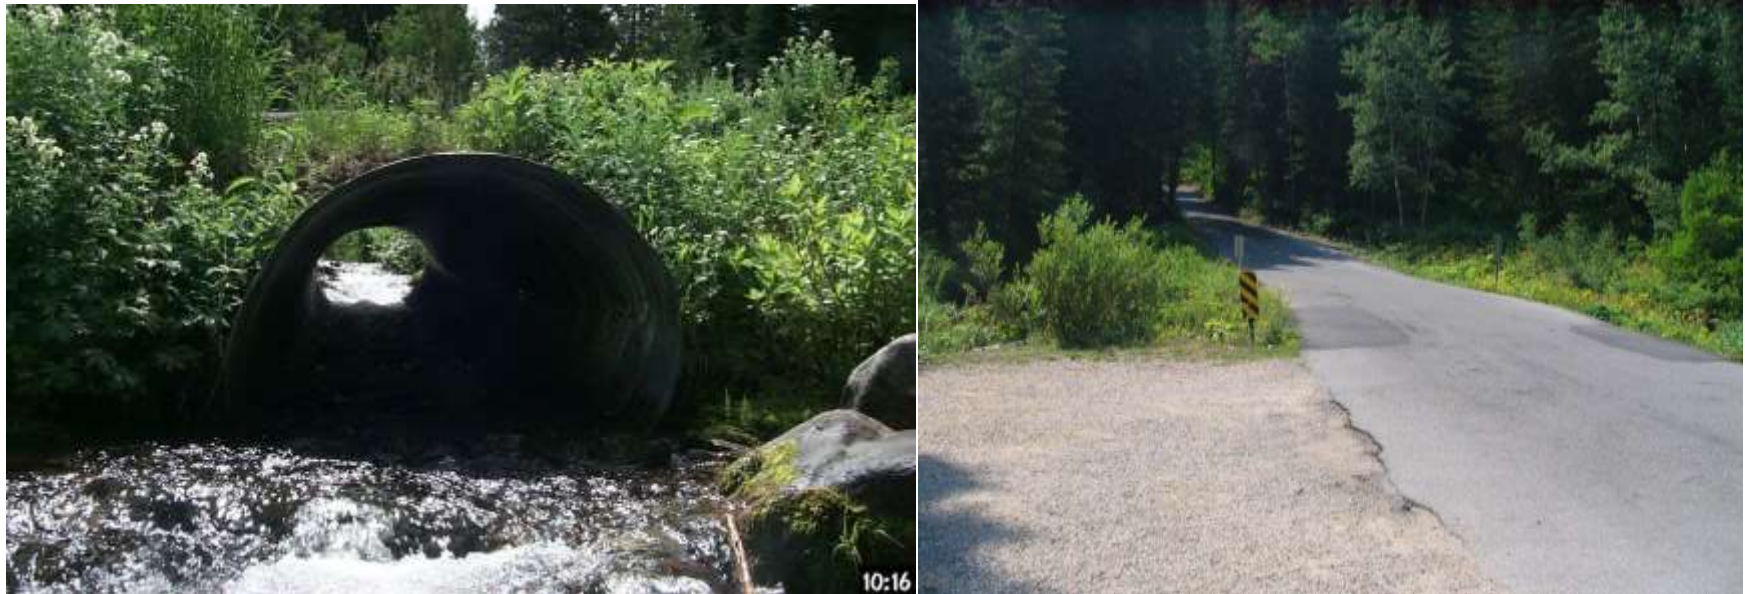
Before photos looking at culvert 10140 looking upstream. Note the patch material on the road surface where the culvert was too short allowing the road surface to slough into the creek.

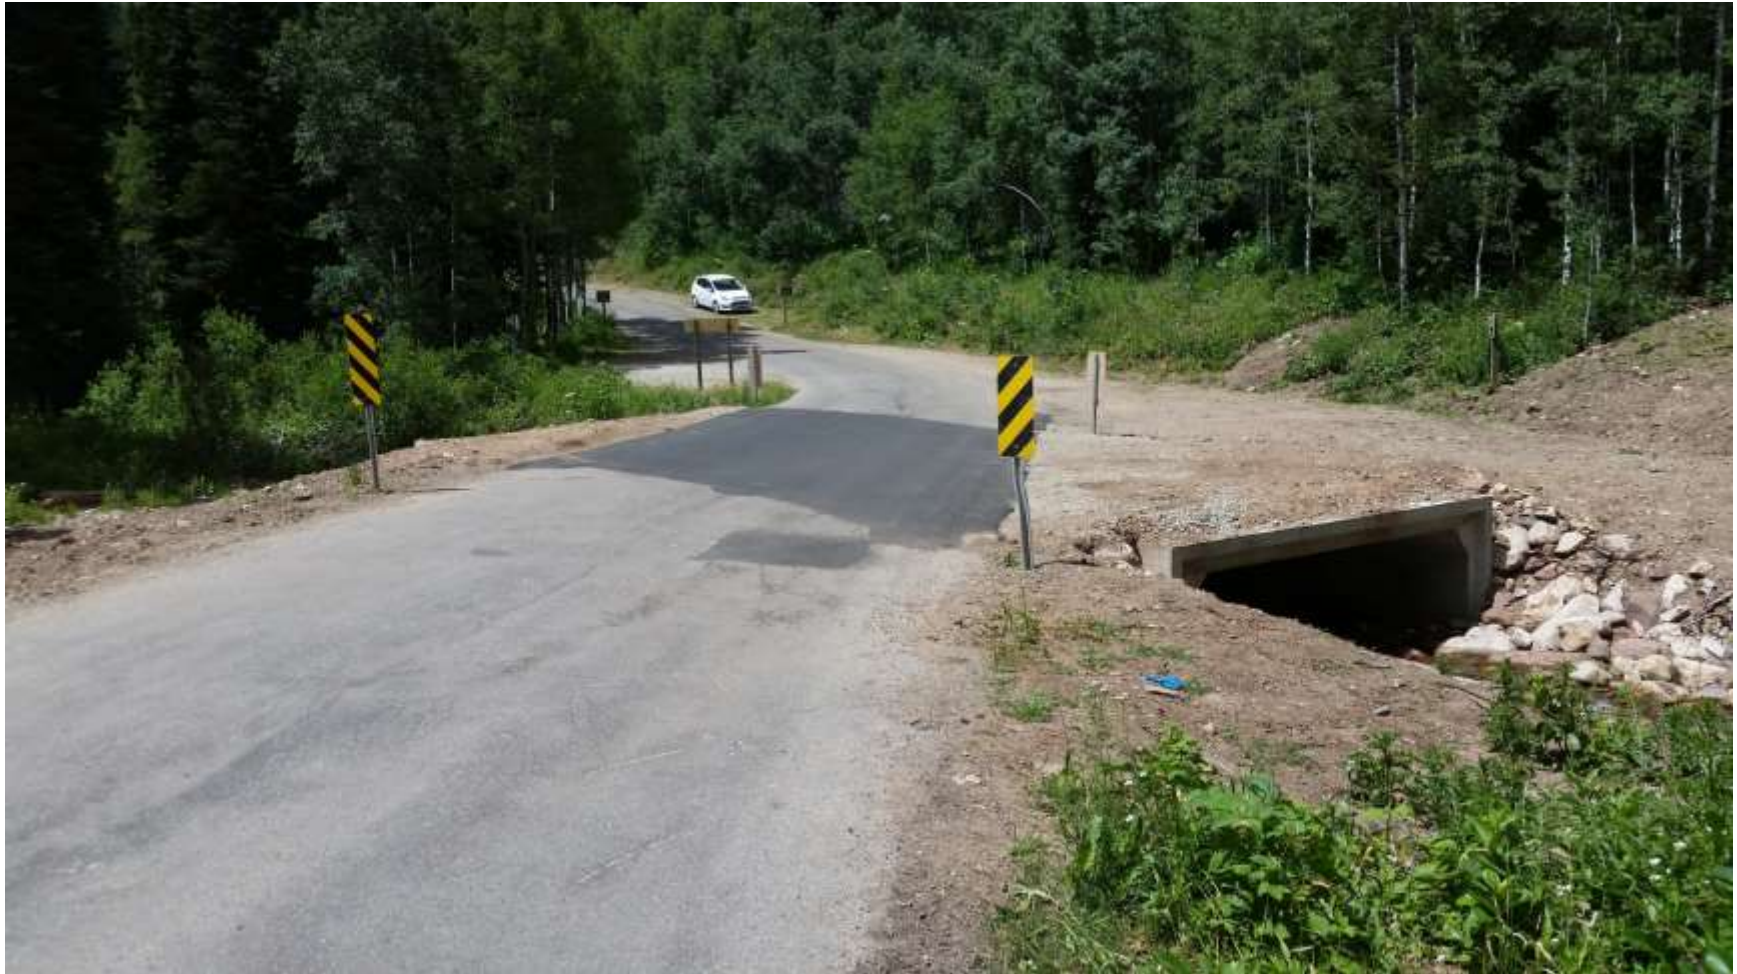
Culvert 10140

New structure with photos taken July 2015 of culvert 10140.

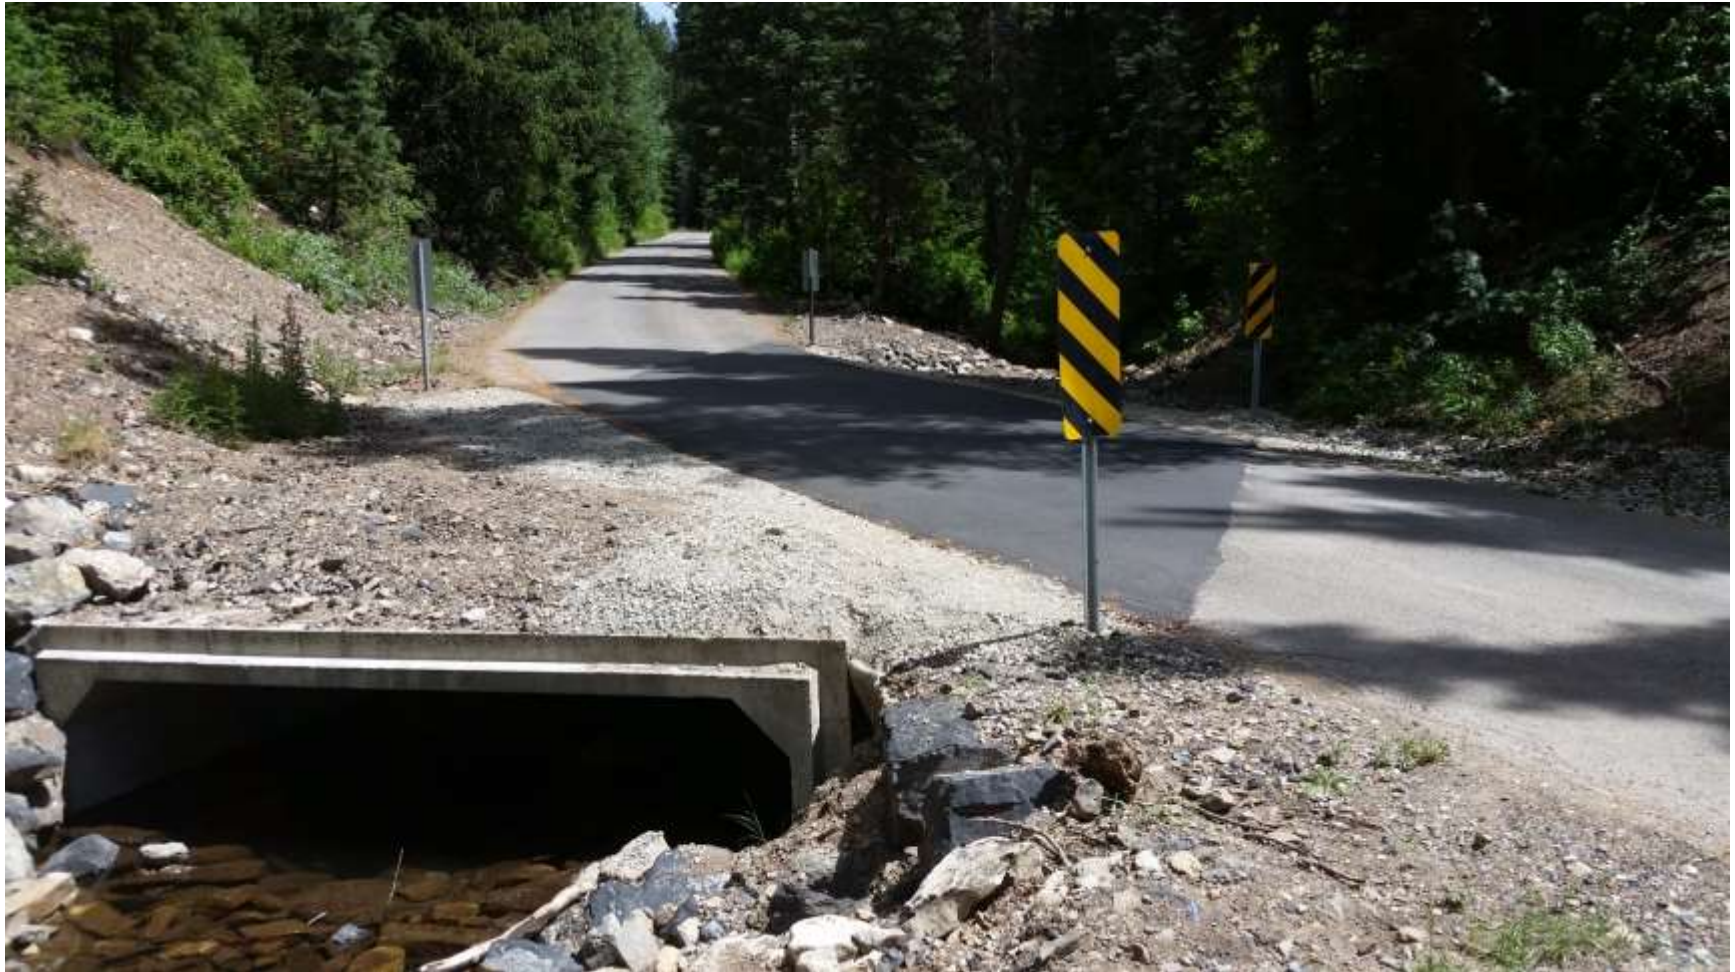
Culvert 10139

Difficulties: Bedrock was encountered on the second culvert. With the culvert sections already precast, the contractor hit bedrock just below the stream surface which required a contract modification and additional equipment to be brought in. This caused about a week delay in the project. In this case a second track hoe with a jackhammer was sufficient to drop the construction bed deep enough to install the precast culvert. Fish and Wildlife Service Funds were used to modify the contract to deal with the bedrock.
